**Contract Report  
CR-98.19-SHR**

**CORRELATION OF  
SURFACE CHLORIDE CONCENTRATION OF  
A PILE EXPOSED TO THE MARINE  
ENVIRONMENT TO THE ADHESIVENESS OF  
A COMMERCIALLY AVAILABLE EPOXY**

**September 1998**

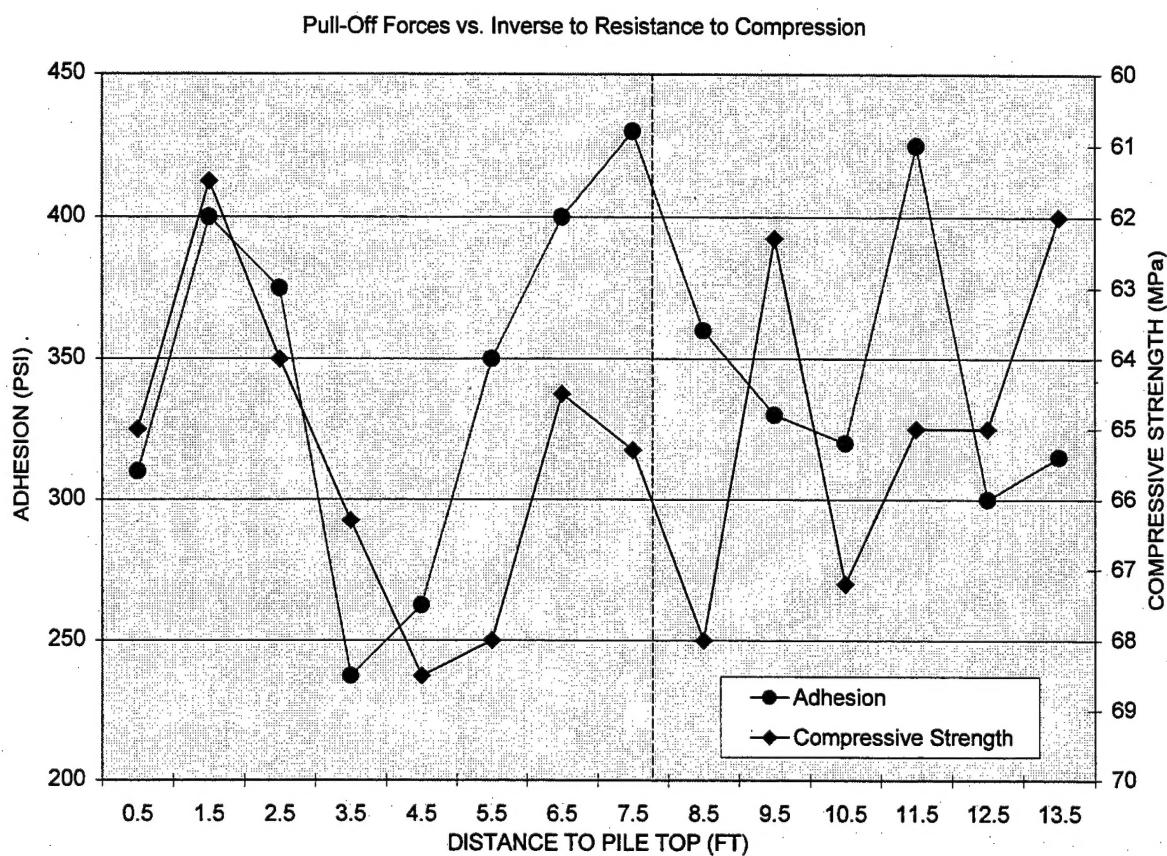
Figure 28. A Correlation of the Adhesiveness of Sikadur 30 Epoxy with the Compression Resistance of the Surface of Pile #1, Face B, a Hydroblasted Surface

The plotted data of Figure 28 is an inverse correlation of adhesiveness of the Sikadur 30 epoxy to the compression resistance of the concrete. This inverse correlation is apparent for the region of the pile above the tidal zone, a correlation that was also evident in Figure 27, that of the surface chloride concentrations. This inverse correlation is surprising but it may be actually due to the higher chloride content rather than the higher strengths, as shown in Figure 27.
